ENCLAD STRUCTURES
residential engineering & inspections

Building Inspection Report for the property at:

Street Address
Your Town, TX 75000

April 29 , 2005

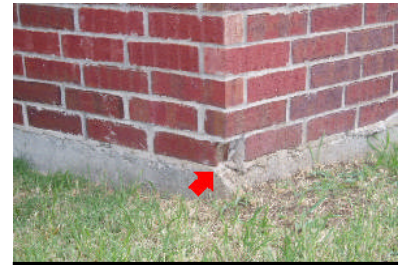
Attention Needed - The exterior siding material or finish is in a condition that requires minor repair to prevent further deterioration.

Broken Brick Course at Back Patio

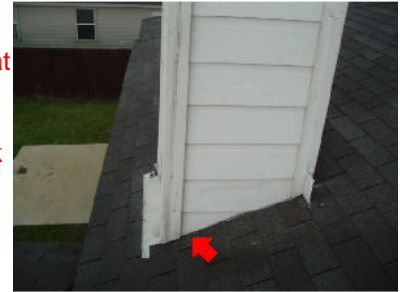
Attention Needed - The trim at the chimney needs some minor repair to prevent further deterioration. The beginning signs of wood rot is present at the chimney trim board.

Also, we recommend the chimney stack be carefully inspected for proper flashing by a roofing contractor, if water appears in the rear bedroom closet. Current homeowner has disclosed that this roof leak has been repaired.

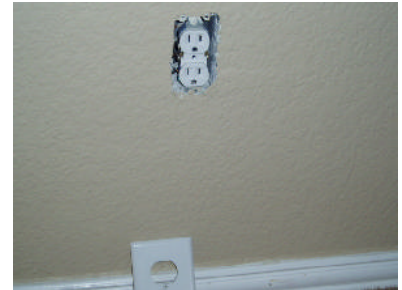
Electrical outlet face plate came loose during the inspection. It is not screwed to the wall.

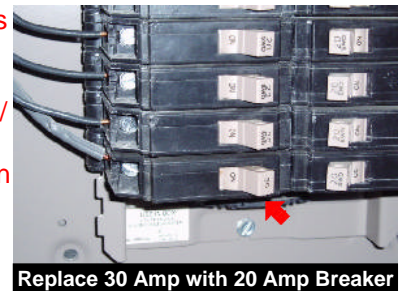
Action Necessary - The breakers/fuses in the main power panel are inappropriately matched with wire gauges that are too light for the breaker/fuse allowed draw. An overdraw condition could cause melting, insulation overheating, or fire. IMMEDIATE ACTION IS RECOMMENDED.

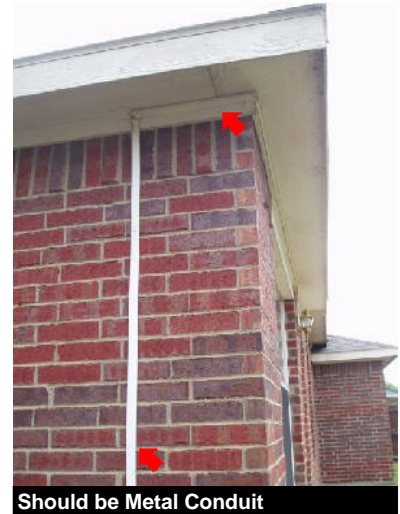
Attention Necessary: The exterior wiring to the back patio lighting should be in metal conduit and completely enclosed from moisture penetration.

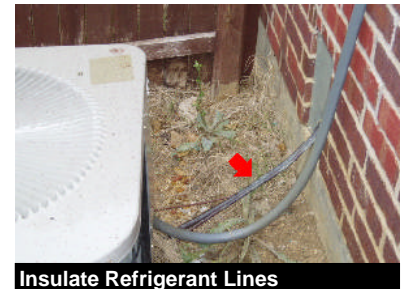
Attention Needed - The refrigerant lines should be wrapped and insulated.

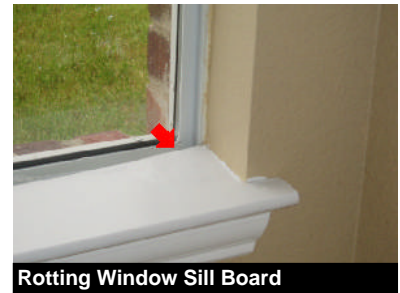
Attention Necessary: The window framing above the tub is not properly installed. The interior window sill board is up to 3/4" above the window framing, leaving a depressed joint for water to gather and rot the sill board.

Rotting Window Sill Board

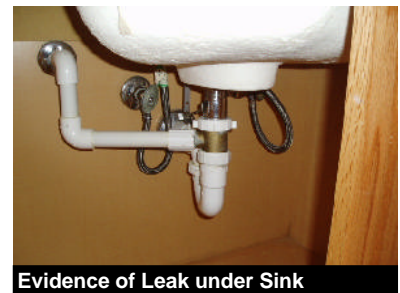
Attention Needed - The basin or drainage fixture needs attention. There is evidence of a leak.

Evidence of Leak under Sink

Action Necessary - Leak Noted - The supply piping under the vanity shows signs of a leak. Services of a Qualified Licensed Plumber are needed. (See note above)
