Level "B" Foundation Inspection:

1234 Your Address
Your Town, TX 12345

January 1st, 2006

Foundation Inspection Report

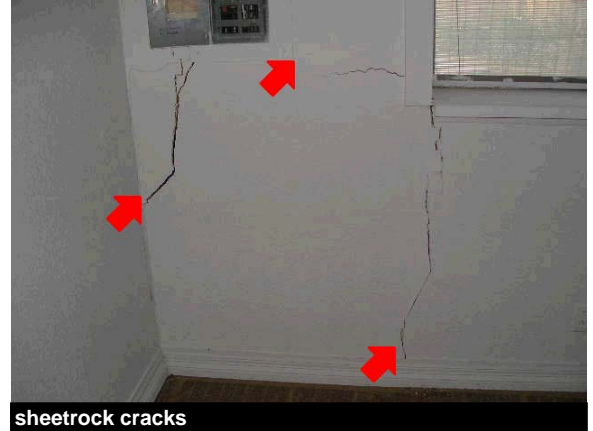
I-1:

On the north wall there is a sheetrock crack below the west end of the window.

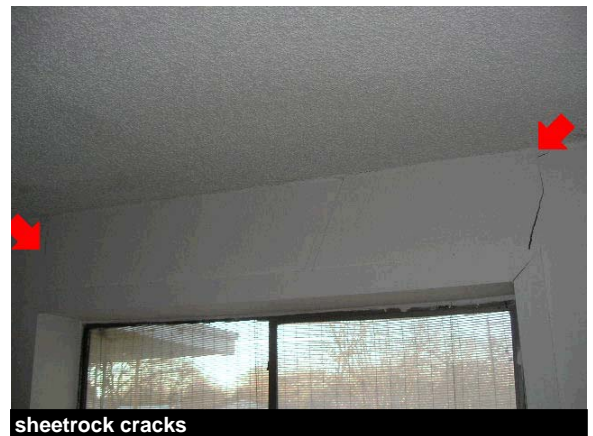
I-2:

On the north wall there is a sheetrock crack above the east and west ends of the window.

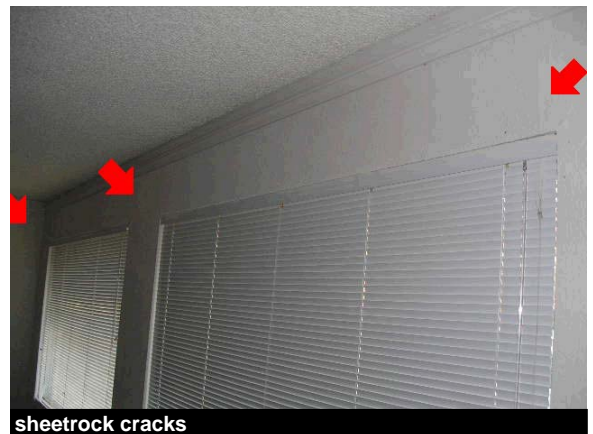
I-3:

On the south wall there is a sheetrock crack above the east and west ends of the windows.

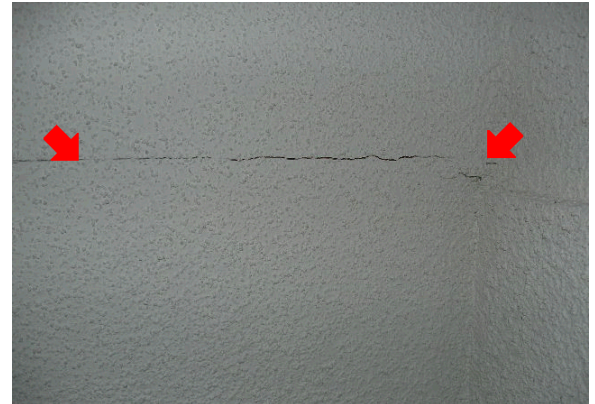
I-4:

On the west side of the living room there is a ceiling sheetrock crack.

ceiling sheetrock crack

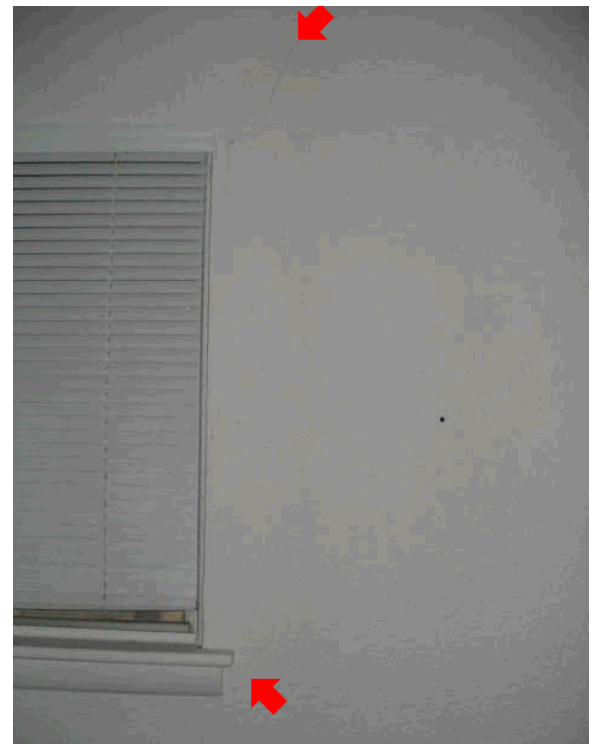
I-5:

On the south wall there is a sheetrock crack above and below the west end of the window.

sheetrock cracks

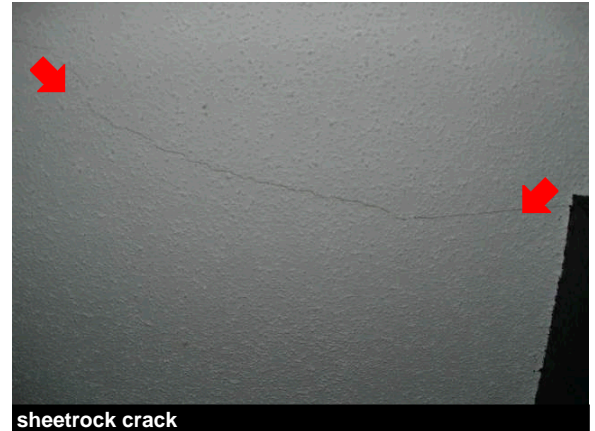
I-6:

On the north side of the bathroom there is a ceiling sheetrock crack.

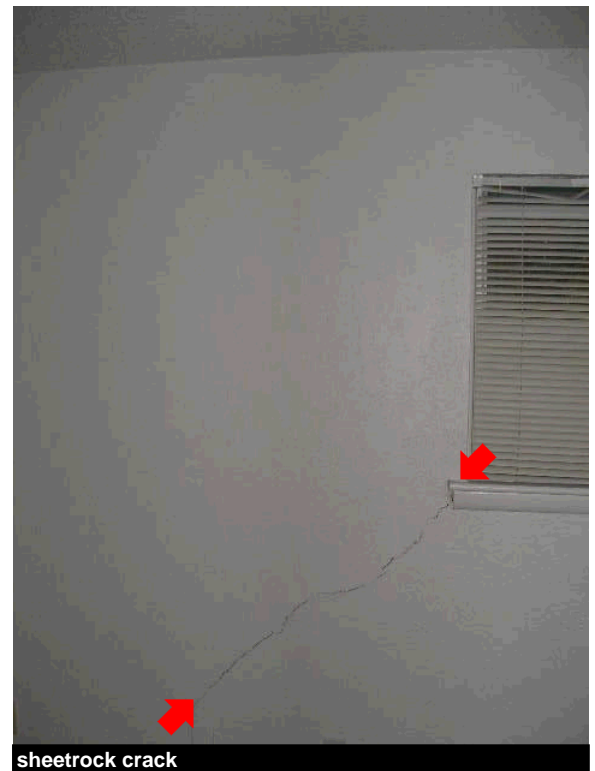
I-7:

The client noted the sheetrock crack on the south side of the structure. [I7]

On the south wall there is a sheetrock crack above and below the east end of the window.

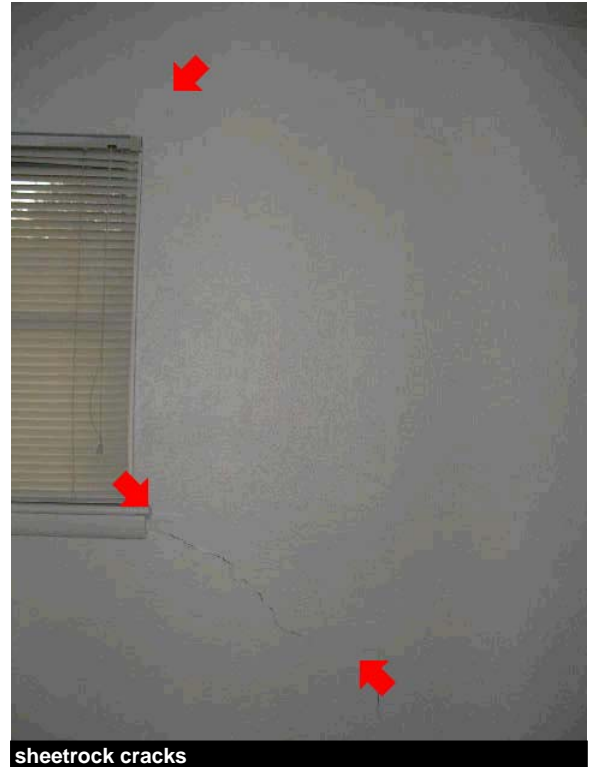
I-8:

On the west wall there is a sheetrock crack above and below the north end of the window.

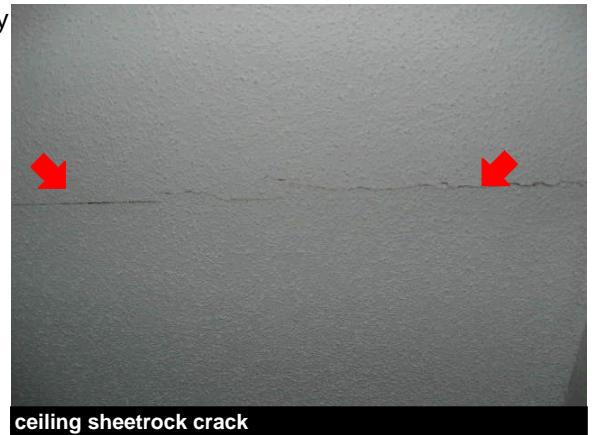
I-9:

On the south side of the hallway there is a ceiling sheetrock crack.

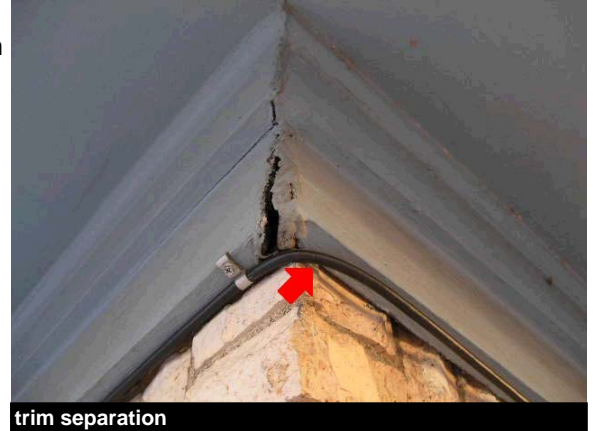
E-1:

On the south side of the structure there is a 1/2 inch trim separation at the southeast corner of the house.

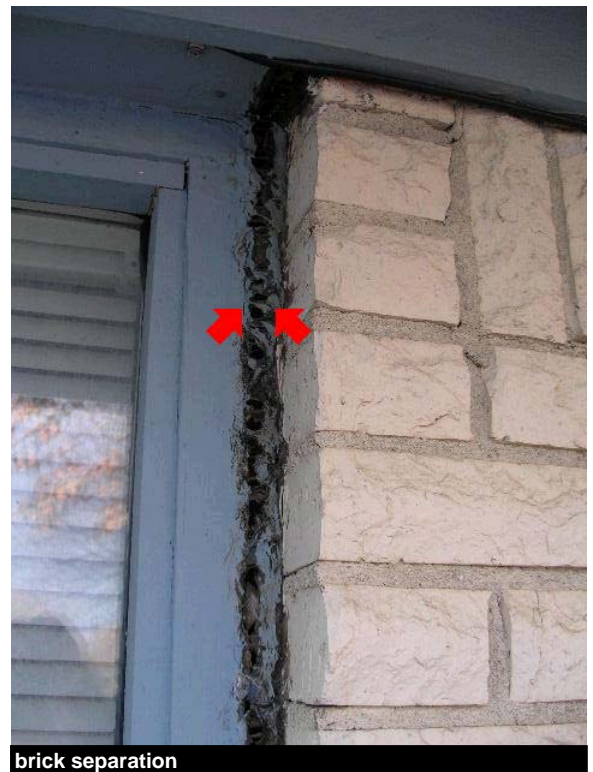
E-2:

On the south side of the structure there is a 1 inch brick separation at the edge of the window.

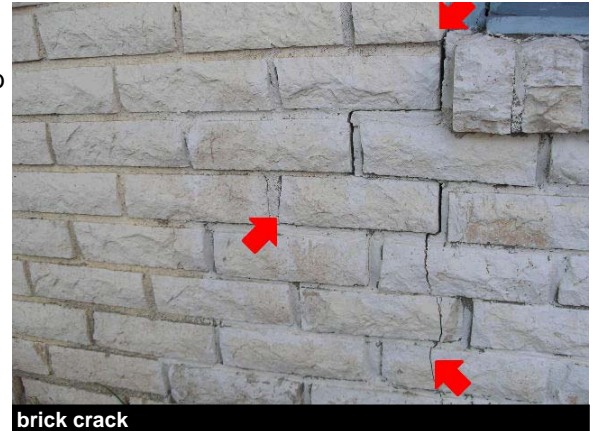
E-3:

On the south side of the structure there is an 1/8 inch brick mortar crack from the slab to the bottom of the window opening.

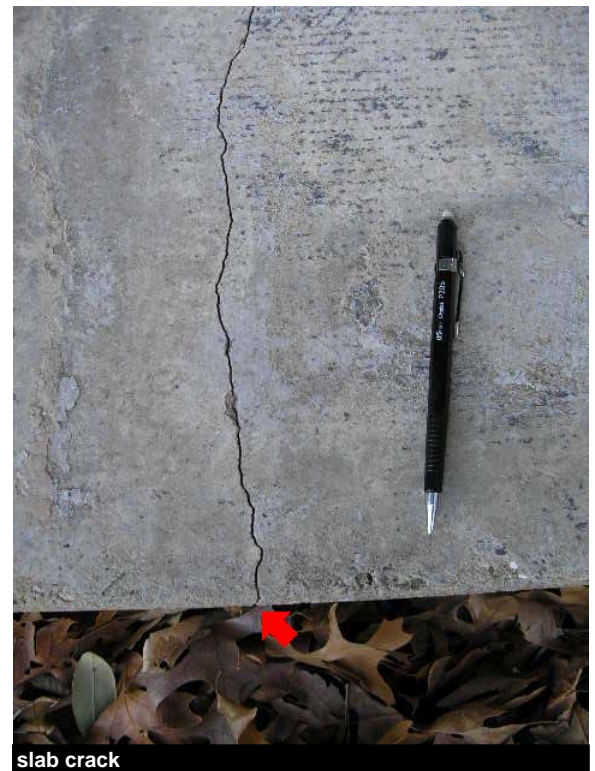
E-4:

On the south side of the structure there is a slab crack.

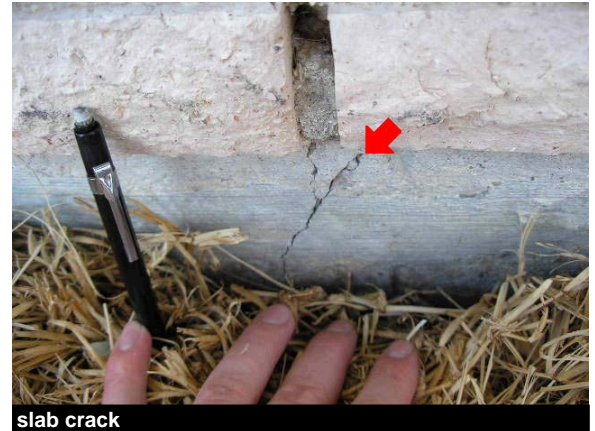
E-5:

The client noted the brick crack on the west side of the structure. [E5]

On the west side of the structure there is a slab crack.

slab crack

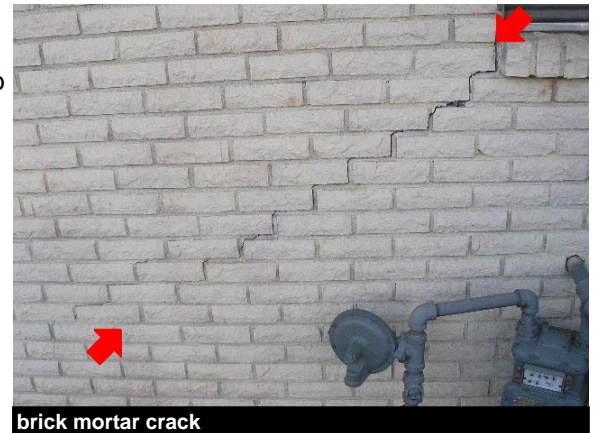
E-6:

On the west side of the structure there is an 1/8 inch brick mortar crack from the slab to the bottom of the window opening.

brick mortar crack

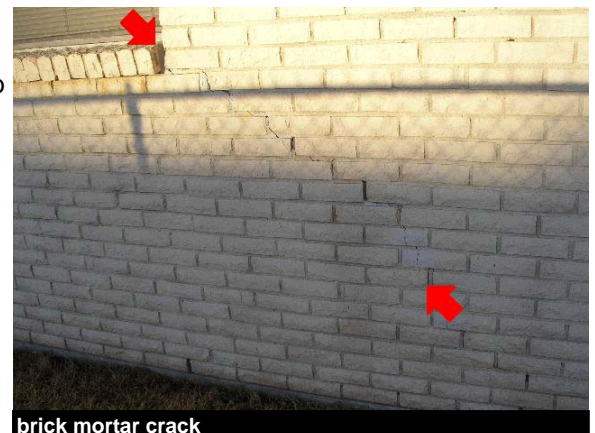
E-7:

On the west side of the structure there is an 1/8 inch brick mortar crack from the slab to the bottom of the window opening.

brick mortar crack

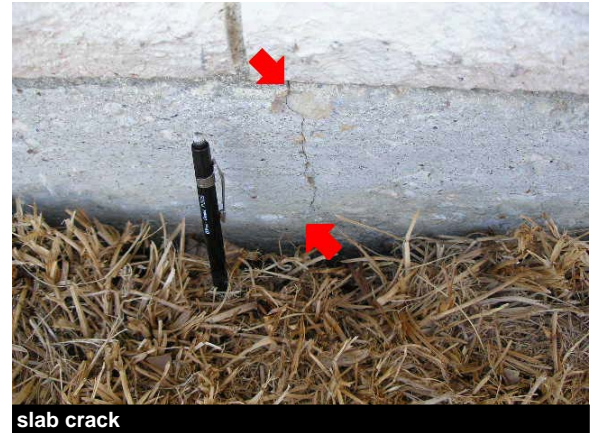
E-8:

On the west side of the structure there is a slab crack.

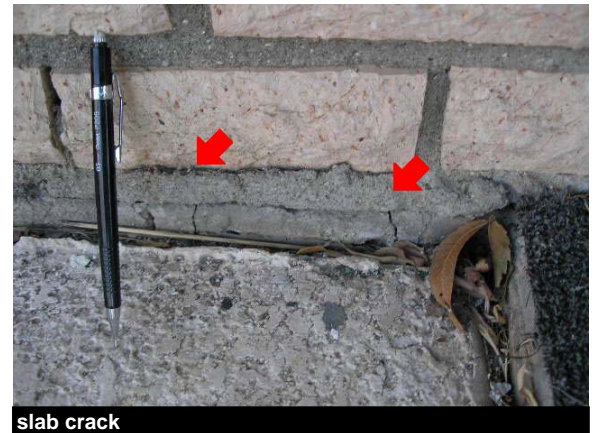
E-9:

On the north side of the structure there is a slab crack.

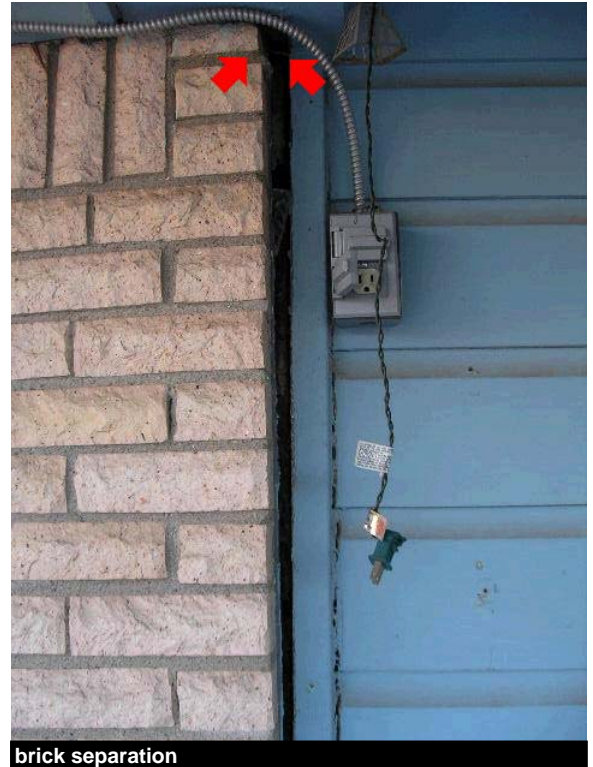
E-10:

On the north side of the structure there is a 1 inch brick separation at the trim.

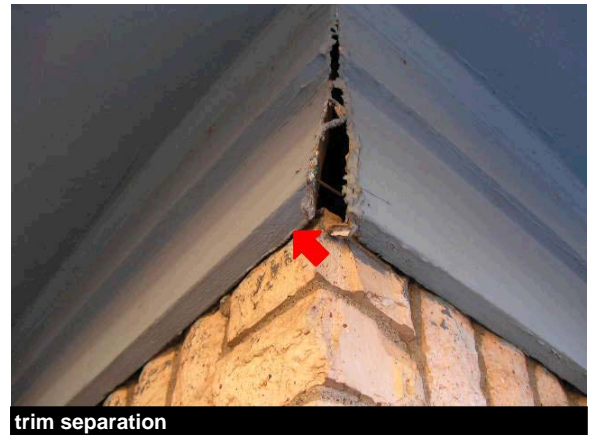
E-11:

On the north side of the structure there is a 1 inch trim separation at the northeast corner of the house.

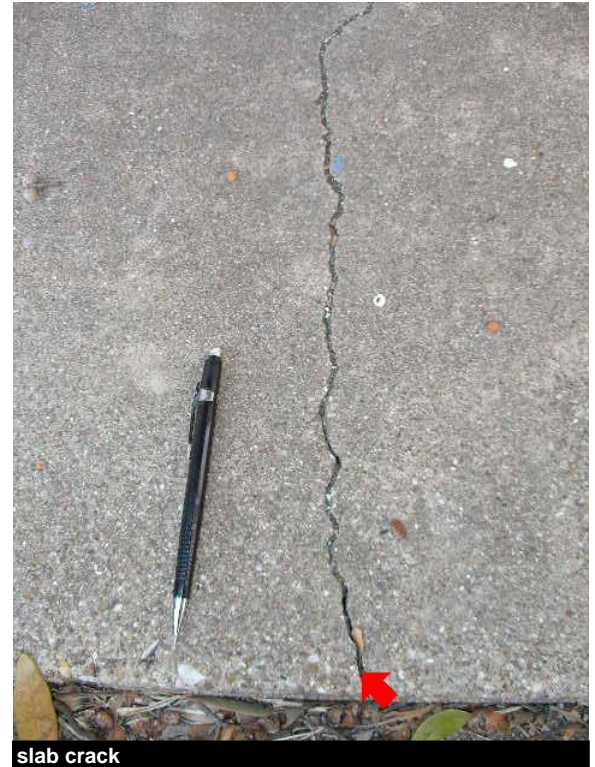
E-12:

The client noted the slab crack on the south side of the garage apron. [E12]

On the south side of the structure there is a slab crack.

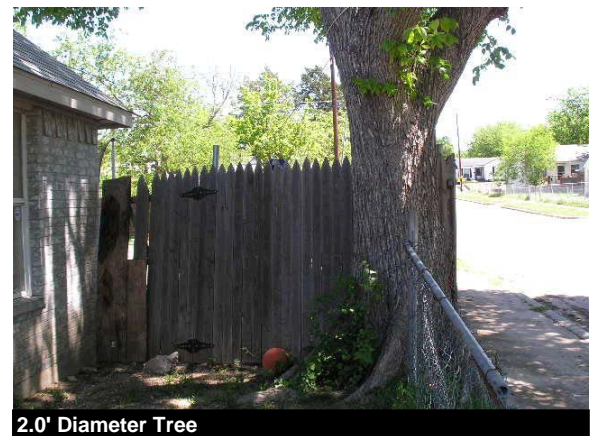
E-13:

On the south side of the property there is a 2 foot diameter tree.

There is a mature tree that is close enough to the foundation to have a significant impact on its performance. When tree root systems encounter soil beneath the foundation, they may utilize this as an additional water source during the dry summer seasons to supplement their moisture needs. This often creates an area with less moisture saturation than areas without trees. The changing saturation levels can cause the areas that have less moisture to settle.

We recommend that 15 ft. of "root barrier" material be installed at 36 in. of depth. Whenever possible place the "root barrier" a minimum of 3 ft. away from the outside edge of the perimeter grade beam.
